INSPECTION REPORT

U.S. ENVIRONMENTAL PROTECTION AGENCY REGION 9

Purpose: RCRA Interim Status Standards (ISS)
Investigation

Facility: Union Manufacturing Inc.
6625 West Allison Rd.
Chandler, Arizona 85224

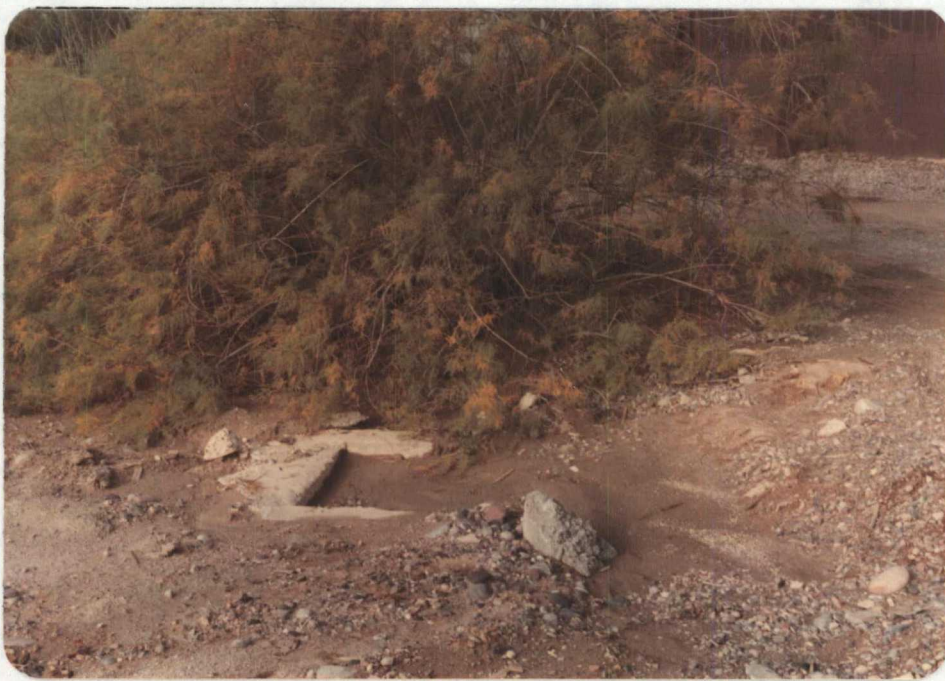
The investigator observed the inactive surface impoundment located near the western property line (Photographs 3-4). Mr. Renn, Paint Shop Supervisor, stated that this impoundment is actually a concrete-lined precipitating tank. Prior to the installation of a new washer in January, 1981; washer rinsate was piped into this leach tank from the building. Mr. Renn stated that chromium, which was used in the old wash process, was removed prior to discharge by adding acids. Mr. Renn stated that the depth of the tank is approximately eight feet, and provided estimates of the tank's dimensions to the investigator. The investigator noted the approximate location of the impoundment (Area B) on a copy of the facility diagram (Appendix 12). Mr. Renn stated that when the impoundment was deactivated, the solids were removed and placed into drums. The tank was then filled in with dirt. Mr. Renn indicated that the solid waste may have been included in the December 1, 1982 waste shipment (See Appendix 11).

3 DATE: 12/1/82 TIME: 2:25 PHOTOG: KO
 WITNESS: M. Gohlmann, R. Renn
 DESCRIPTION: Inactive concrete-lined tank/
 surface impoundment which was used to
 contain/precipitate wash wastes.

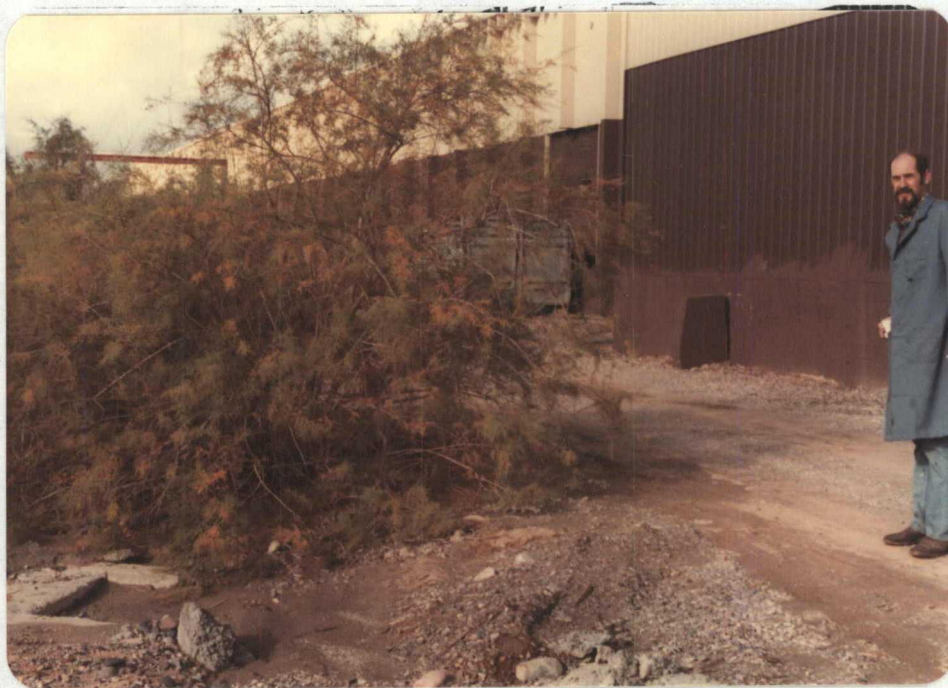
4 DATE: 12/1/82 TIME: 2:30 PHOTOG: KO
 WITNESS: M. Gohlmann, R. Renn
 DESCRIPTION: Washer wastes were discharged
 via a pipe connected from the building to the
 tank. The tank extended to where Mr. Renn
 is standing (Approx 10 ft. long).

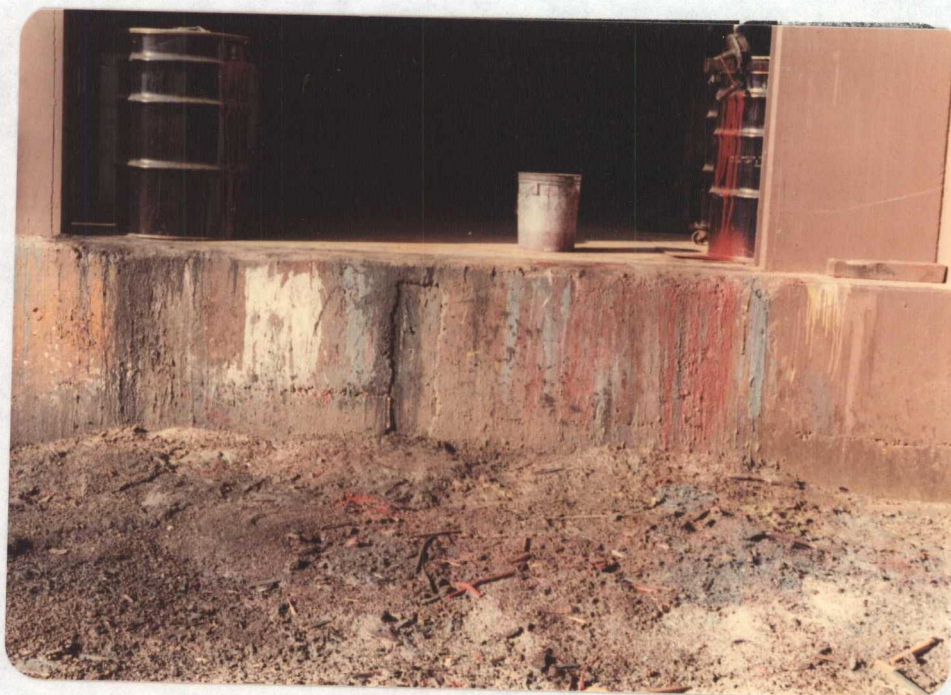
The investigator observed an accumulation of paint waste on the soil, below a loading dock in the Paint Storage Room (Photographs 5, 6). Mr. Renn stated that when drums of paint caught on fire, they were thrown off the dock onto the ground. This disposal site is identified as Area D on Appendix 12.

5 DATE: 12/1/82 TIME: 2:35 P PHOTOG: Ico
 WITNESS: M. Gohlmann, R. Renn
 DESCRIPTION: Loading Dock in Paint Storage Area. Drums of paint on fire used to be thrown off the dock in emergencies.

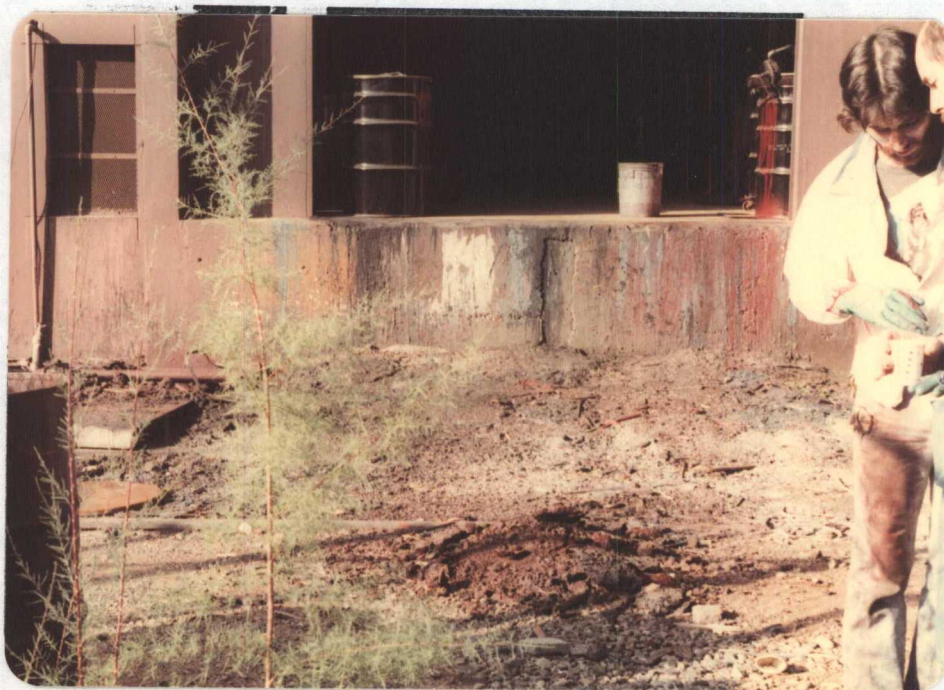
6 DATE: 12/1/82 TIME: 2:37 P PHOTOG: Ico
 WITNESS: M. Gohlmann, R. Renn (see above)
 DESCRIPTION: Mr. Renn stated that is method of disposal ceased approx. 1 1/2 years ago. Accumulation of paint was has covered RR tracks.

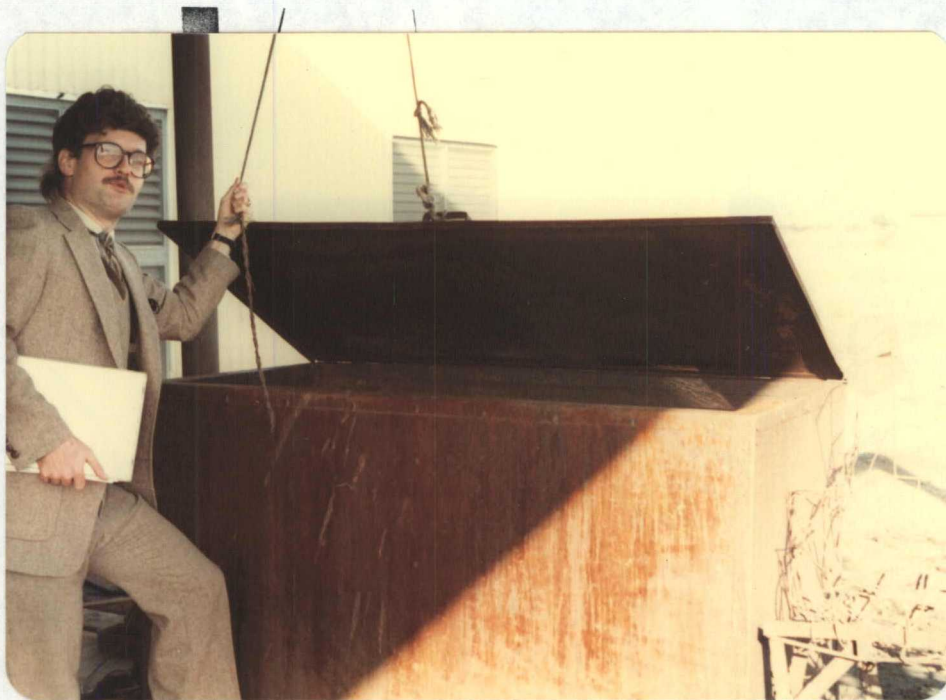
The investigator observed the covered paint stripping tank, located on a concrete pad south of the production building (Photograph 7). The investigator observed the paint stripping sludge disposal area adjacent to the southern and eastern sides of the concrete pad (Photographs 8, 9). Mr. Renn estimated that the land disposal of paint stripping sludge ceased in April, 1981. Approximate dimensions of this disposal site (Area A) are noted on Appendix 12. The investigator observed a pipe, which extends from Area A to a

7 DATE: 12/1/82 TIME: 2:40 PPHOTO: KO
 WITNESS: M. Gohlmann, R. Renn
 DESCRIPTION: 330 Gallon metal paint stripping tank containing Westerns- Epoxy-Stripper. Screen to collect solids is located at the bottom of the tank.

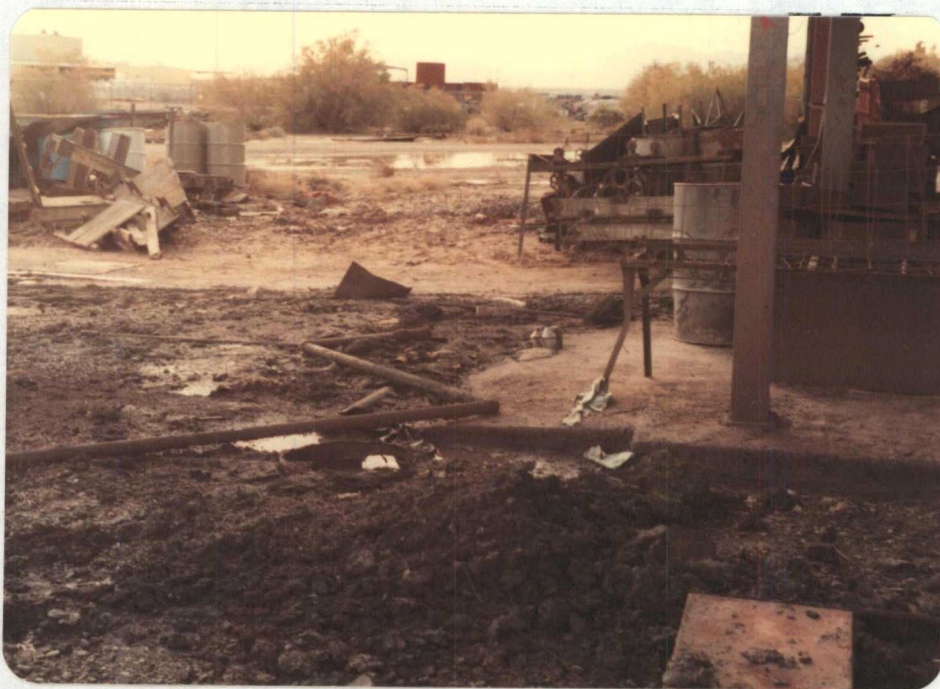
8 DATE: 12/1/82 TIME: 2:45 PPHOTO: KO
 WITNESS: M. Gohlmann, R. Renn
 DESCRIPTION: Land disposal of paint stripping sludge adjacent to concrete pad in Paint Stripping Area.

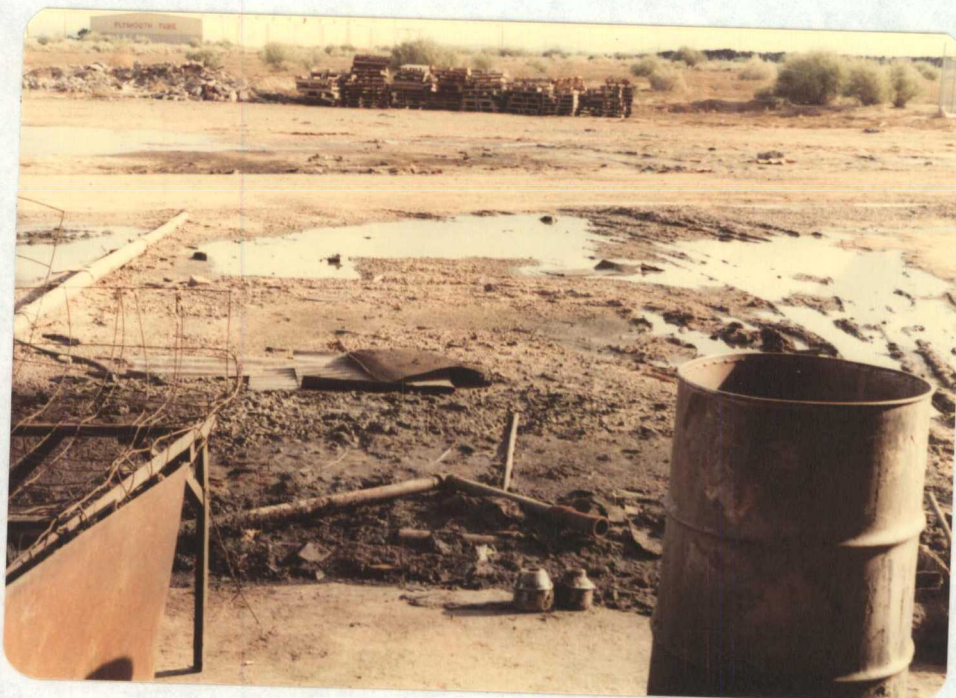
9 DATE: 12/1/82 TIME: 2:47P PHOTOG: KO
 WITNESS: M. Gohlmann, R. Renn
 DESCRIPTION: Facing South. Disposal of
 paint stripping wastes extends 6-8 feet
 from concrete pad. Note ponded water.

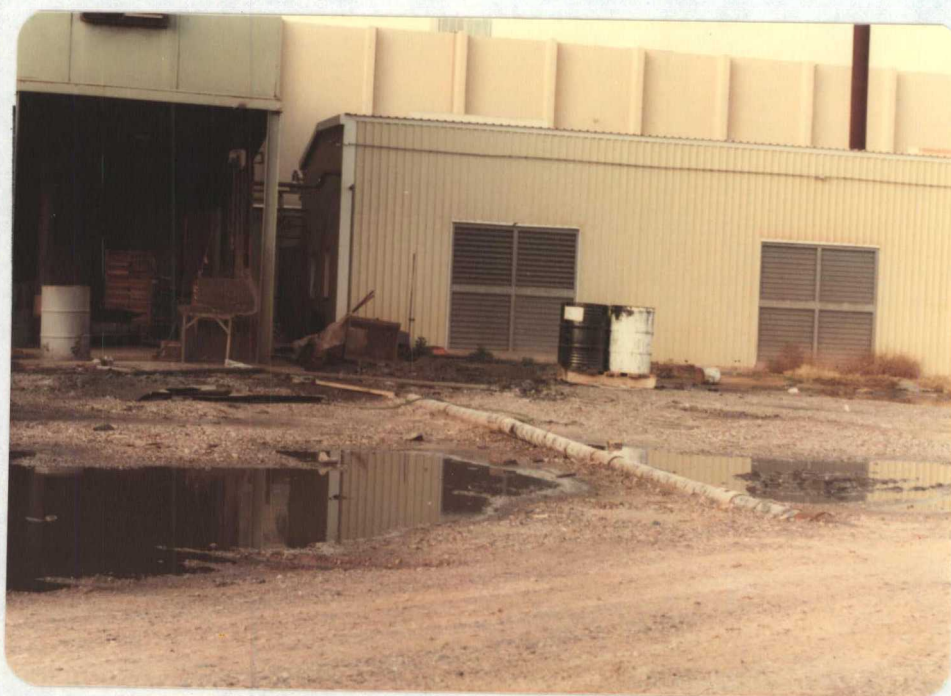
potentially contaminated area approximately 30-40 feet south (Photograph 10). This pipe is used to drain excess water from the paint stripping sludge disposal area. Dark stains and an accumulation of sludge were observed in this second waste area, especially near the discharge point (Photographs 11-14). A large pool of water was observed in this area (Photograph 12). This wastewater disposal site is identified as Area B in Appendix 12.

10 DATE: 12/1/82 TIME: 2:50P PHOTOG: KO
 WITNESS: M. Gohlmann, R. Renn
 DESCRIPTION: Facing North. Note pipe
 which drains contaminated water from
 paint stripping waste disposal area.

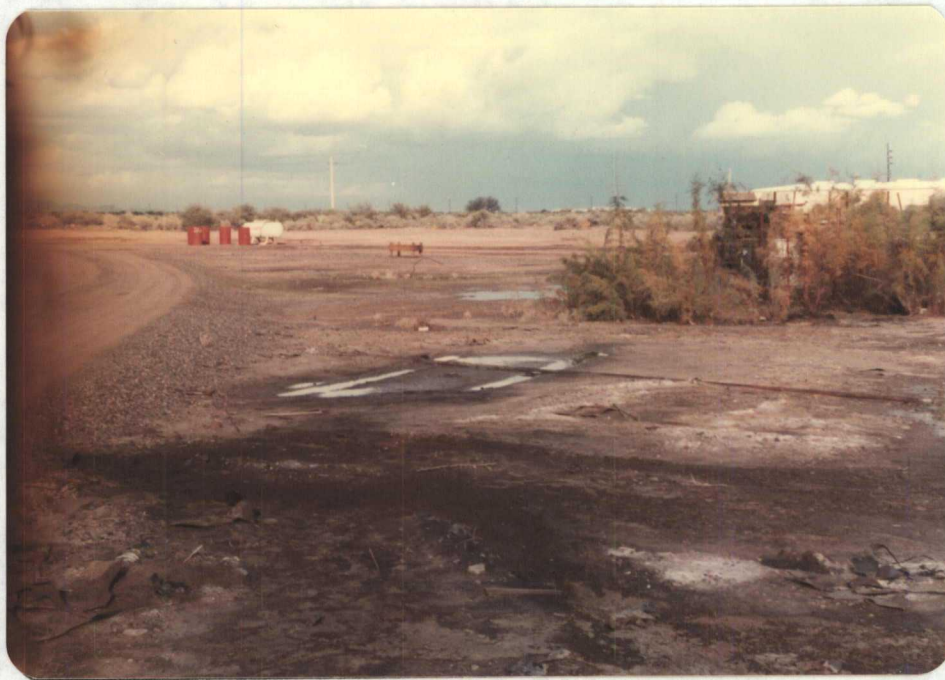
11 DATE: 12/1/82 TIME: 3:00P PHOTOG: 100
 WITNESS: M. Gohlmann
 DESCRIPTION: Waste disposal area connected
 to the Paint stripping sludge disposal area
 (Photos 8-10) via a pipe. Arrow shows discharge point.

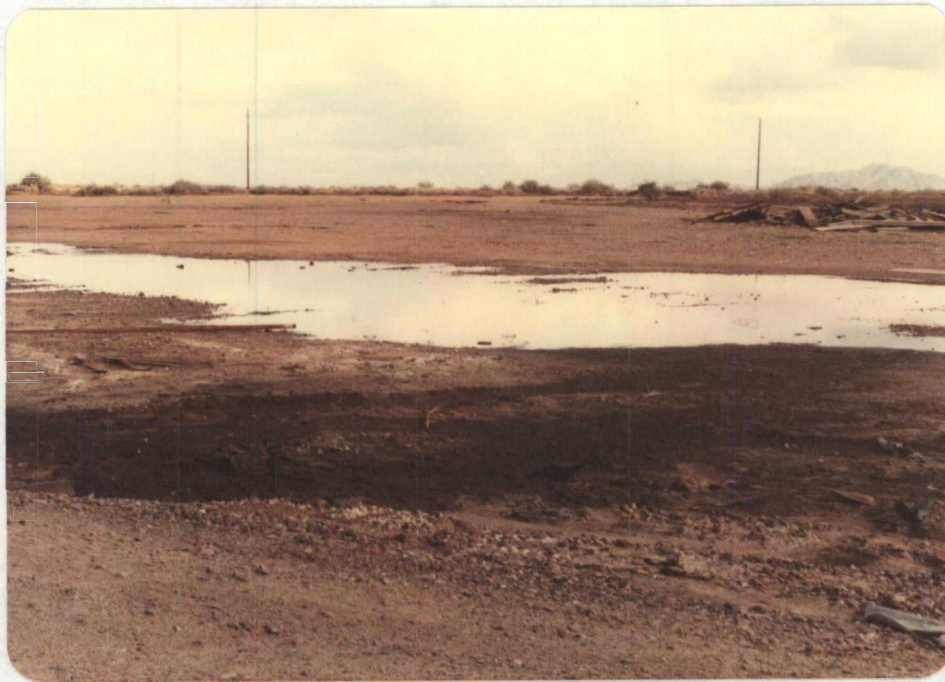
12 DATE: 12/1/82 TIME: 3:05P PHOTOG: 100
 WITNESS: M. Gohlmann
 DESCRIPTION: see above description. Facing
 South. Note dark stains and accumulation of
 sludge. Note ponded water in area.

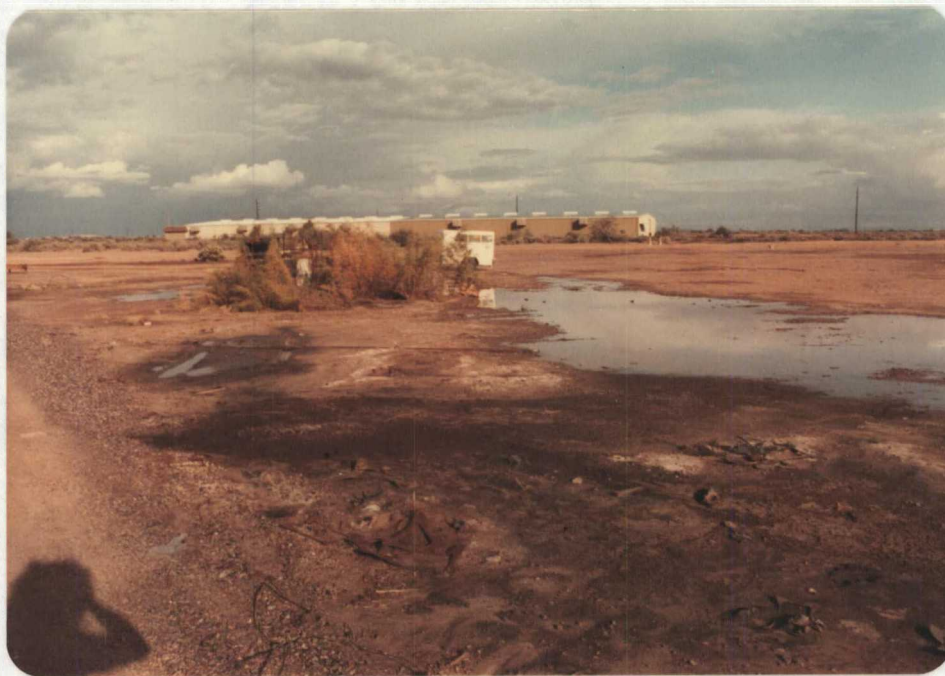
13 DATE: 12/1/82 TIME: 3:10 PHOTOG: 100
 WITNESS: M. Gohlmann
 DESCRIPTION: Facing East. Hazardous
 Waste Storage area is located behind bushes
 near sludge/wastewater disposal area (See
 Arrow)

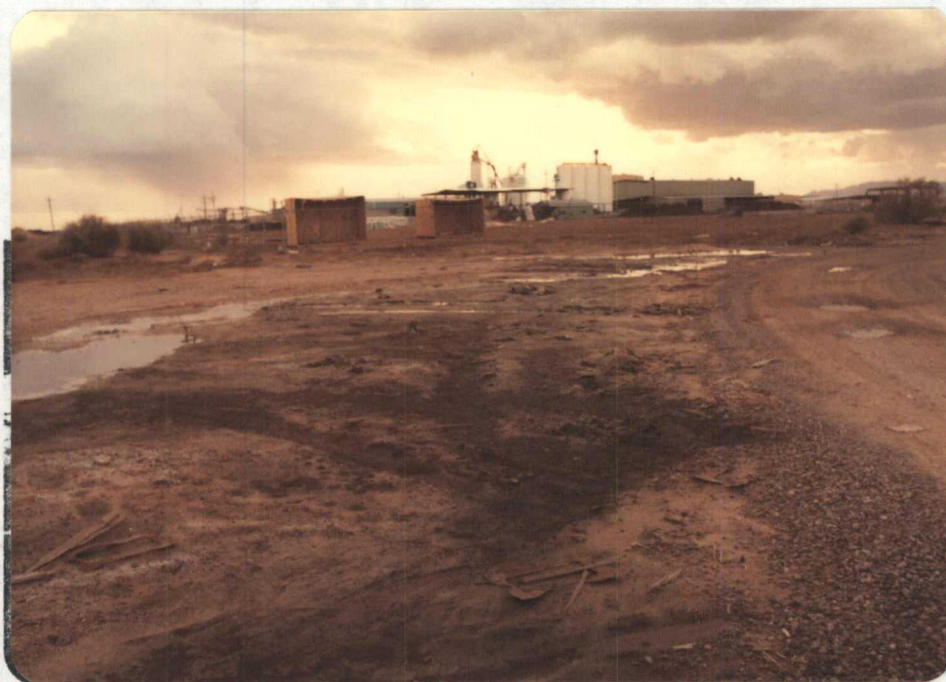
14 DATE: 12/1/82 TIME: 3:20 PHOTOG: 100
 WITNESS: M. Gohlmann
 DESCRIPTION: Facing West. See
 descriptions for photos # 11, 12.

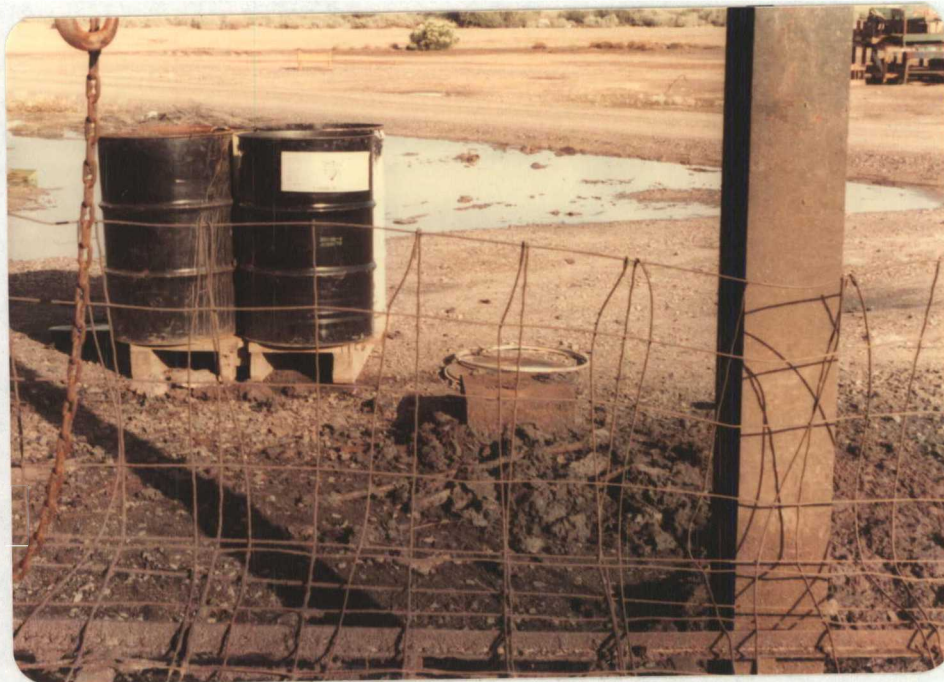
Four open drums of sludge were observed on pallets, adjacent to the Paint stripping tank (Photographs 15, 16). Mr. Renn stated that Union Manufacturing has been slowly removing paint stripping waste from the ground, and placing it into the drums. In the future, Mr. Renn plans to reclaim the methylene chloride in the stripping compound by settling the solids in open drums, and skimming the solvent from the surface.

15 DATE: 12/ 1 /82 TIME: 2:55 PHOTO: 106
 WITNESS: M. Gohlmann, R. Renn
 DESCRIPTION: Facing East. Four open drums of paint stripping waste located in paint stripping area.

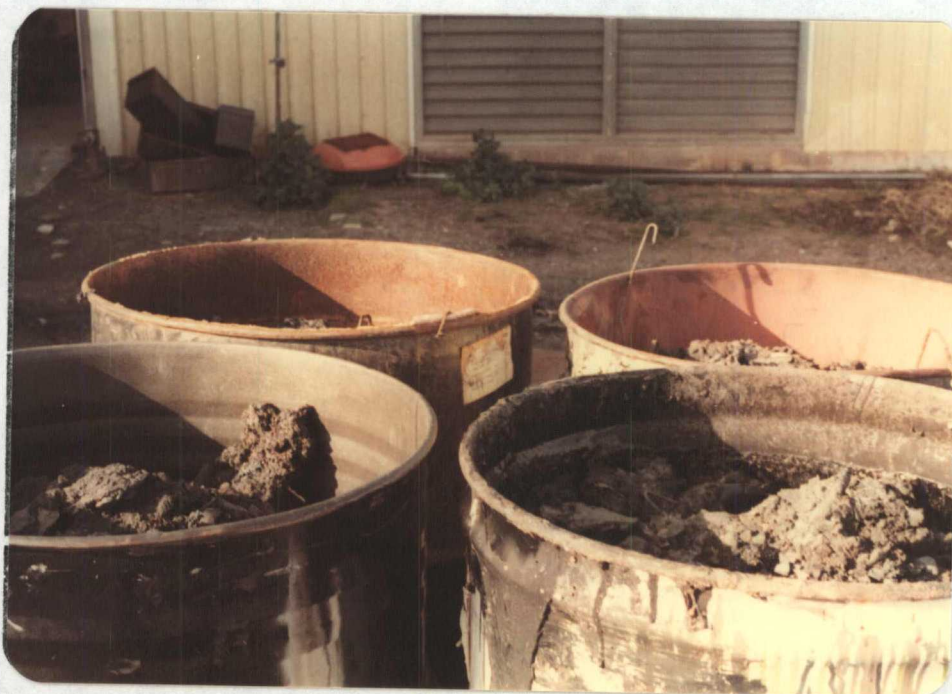
16 DATE: 12/ 1 /82 TIME: 2:57 PHOTO: 100
 WITNESS: M. Gohlmann, R. Renn
 DESCRIPTION: See above. Mr. Renn stated that Union Mfg. has been slowly cleaning up sludge on the ground and placing in drums

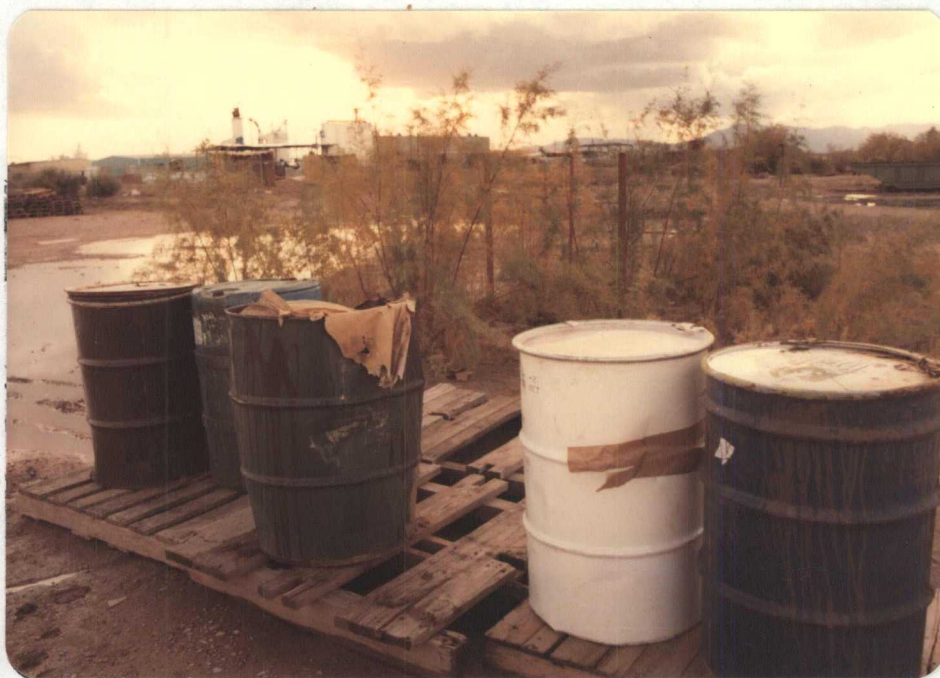
17 DATE: 12/1/82 TIME: 3:15 PHOTOG: 100
 WITNESS: M. Gohlmann
 DESCRIPTION: Facing West, Hazardous Waste
 Storage Area (unfenced, uncovered). Note
 tape on white drum (2nd from right)

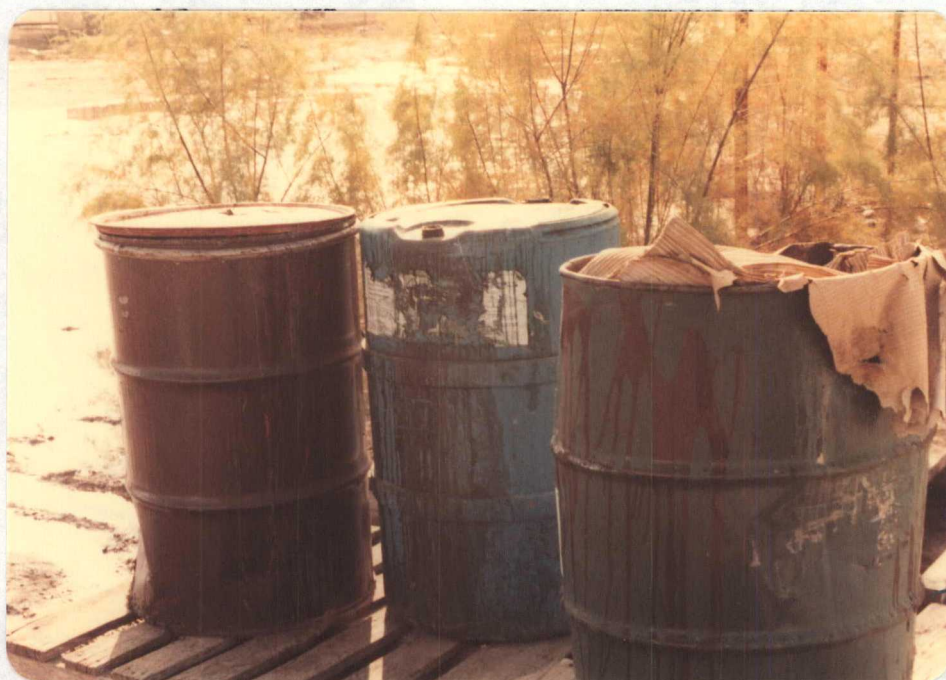
The investigator observed that one of the drums was open and badly dented, and another drum had an unsecured lid (Photograph 18). Several drums were in poor condition, and the pallets upon which they rested were damaged (Photographs 19, 20). Mr. Gohlmann, who was unable to identify the contents of the drums, stated that the containers are probably labeled incorrectly.

18 DATE: 12/1/82 TIME: 3:20 PHOTOG: 100
 WITNESS: M. Gohlmann
 DESCRIPTION: From Left to Right:
 1) Unsecured lid on drum at left
 2) Evidence of leaks on center drum
 3) Open drum at right - see Photo 19.

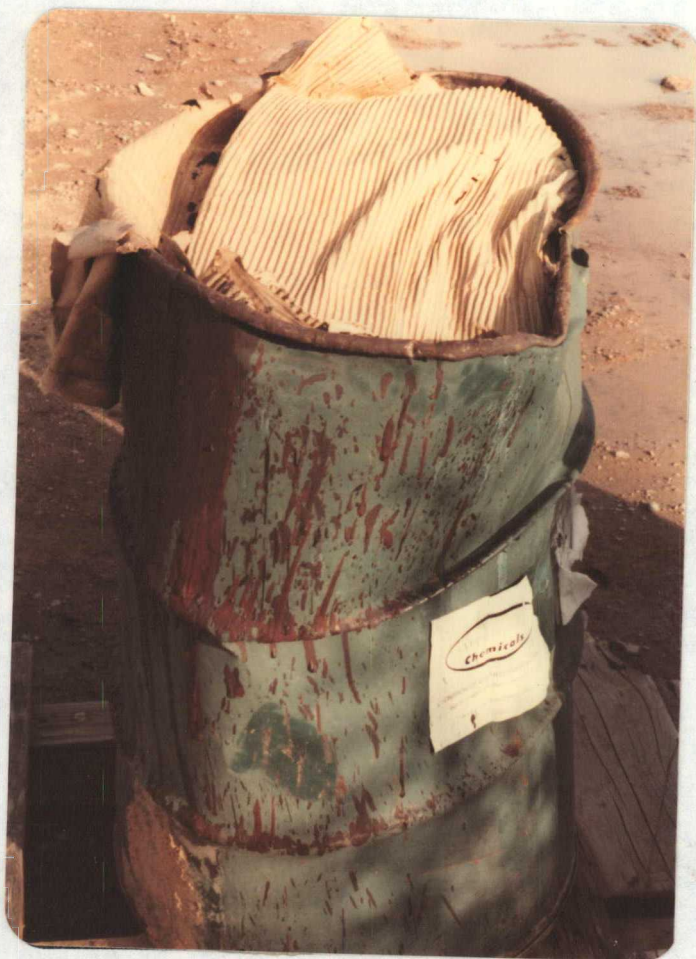
#19 DATE: 12/1/82 TIME: 3:25 PHOTOG: KO
 WITNESS: M. Gohlmann
 DESCRIPTION: Badly dented, open drum
 containing waste. Mr. Gohlmann was
 unable to identify contents of any drums.

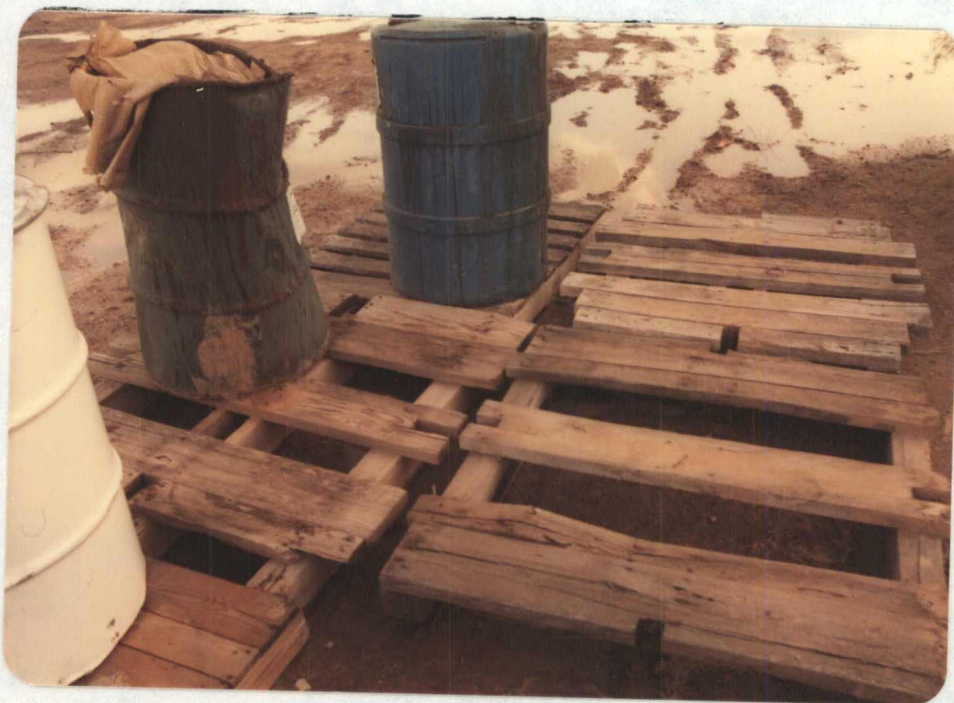
#20 DATE: 12/1/82 TIME: 3:30 PHOTOG: KO
 WITNESS: M. Gohlmann
 DESCRIPTION: Broken pallets used for
 hazardous waste storage. Note
 ponded water; no secondary containment.
